Manhole Inspection Summary

Manhole # S33EE_F04MH

Location Address: **MARTIN LUTHER KING BLVD**

Cross Street: **HOWARD ST**

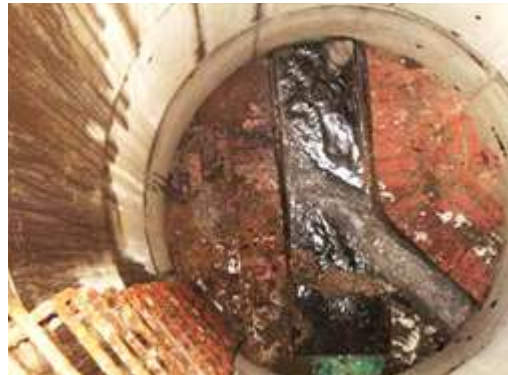
Top View

☐ Parged ☒ **Debris** (not Condition related)

☒ **Debris** (not Condition related)

Count: **19** Missing: **0** ☒ **Corroded**

Corroded steps. Bench and Channel debris.

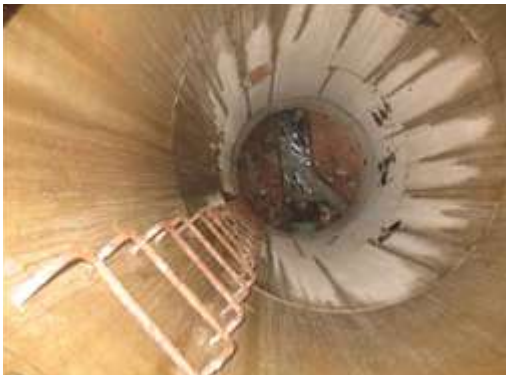
Defect

Infiltration: ☐ None ☒ **Joint** ☐ Cracks ☐ Mortar ☐ Roots ☐ Wall

Infiltration: ☐ None ☒ **Joint** ☐ Cracks ☐ Mortar ☐ Roots ☒ **Wall**

Corbel and Barrel infiltration.

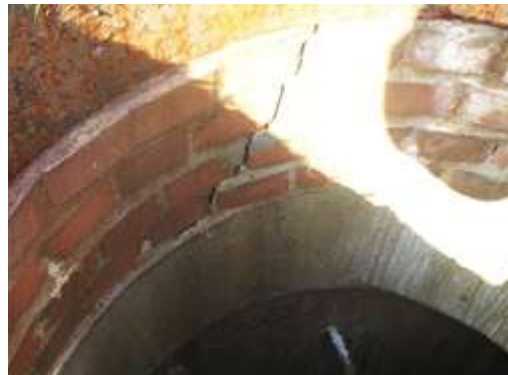
Defect

Condition: ☐ Sound ☒ **Cracked** ☐ Root Intrusion ☐ Loose Brick ☐ Deteriorated

Infiltration: ☐ None ☒ **Joint** ☒ **Cracks** ☒ **Mortar** ☐ Roots ☐ Wall

Frame leaks. Adjustment cracks and infiltration. Corbel and Barrel infiltration.

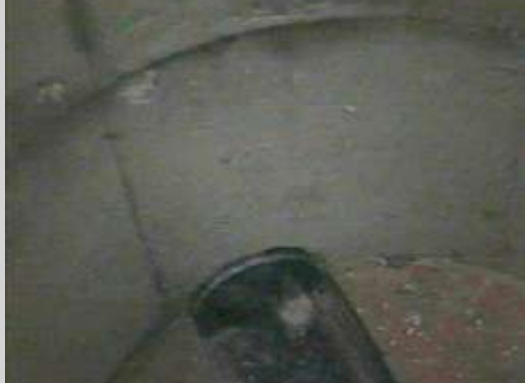
18 in. Circular Gravity Sewer Pipe Out @ 12 O'Clock

Infiltration: **Evidence**

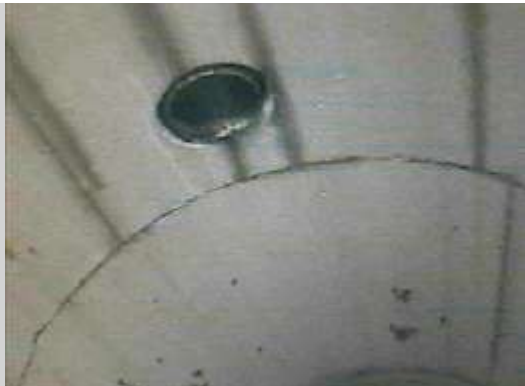
8 in. Circular Gravity Sewer Pipe In @ 5 O'Clock

Infiltration: **Evidence**

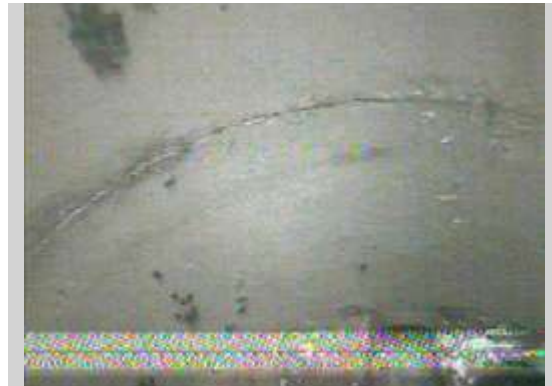
Drop In @ 5 O'Clock

Drop: **Outside** Rod and Bar
Angled: **Yes** Reading: **23.17** (ft.)
Inv Depth: **24.17** (ft.)

Drop Condition: **Open**

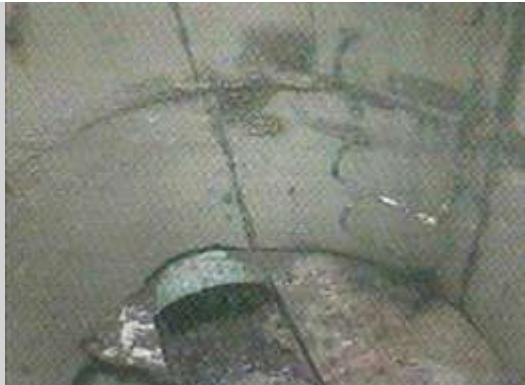
Pipe In @ 6 O'Clock

Infiltration: **Evidence**

Connects To: **Stub connection / abandoned**

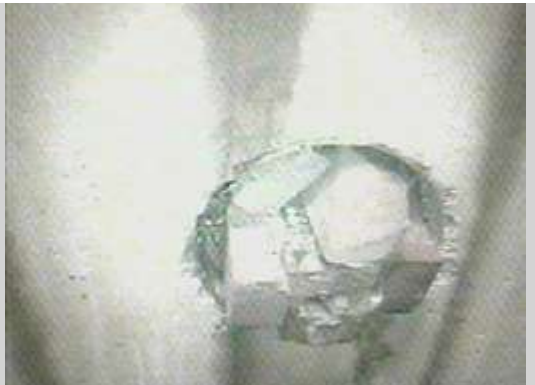
Pipe In @ 10 O'Clock

Infiltration: **Evidence**

Connects To: **Stub connection / abandoned**
